**Flood Control Project Maintenance  
Levee Inspections****LMA District Cover Sheet****Spring 2011 Levee Inspection Results****Levee District No. 0009 (Sutter County)**

**Levee Inspection Report By Mile - Spring 2011**

Waterway						Bank	Unit Miles	Inspection Start/End	Inspector
Unit No. 01 Sutter County, Feather River						Right	6.24	03/15/2011 03/15/2011	Clay Thomas

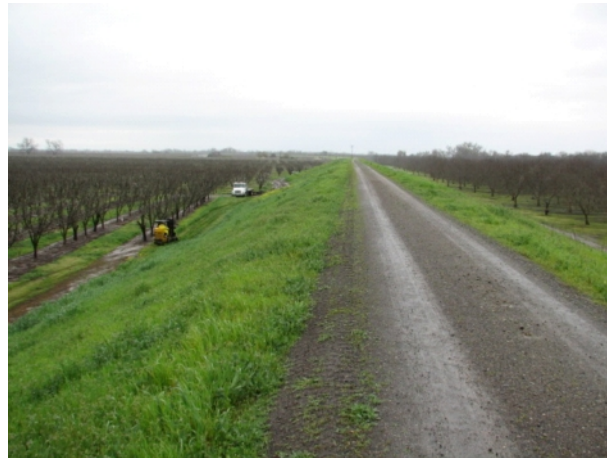
Levee Mile Report Line	2
Start Levee Mile	0.40
End Levee Mile	0.40
Location	Land Side
Category	Earthen Levee
Item	Vegetation

Levee mile 0.40, vegetation on the landside of the levee.

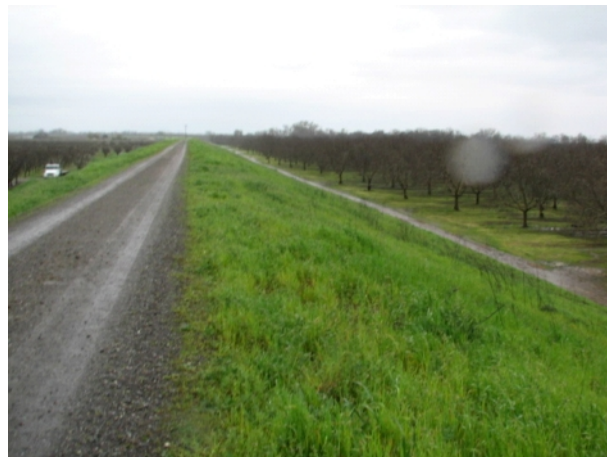
Levee Mile Report Line	3
Start Levee Mile	0.40
End Levee Mile	0.40
Location	Water Side
Category	Earthen Levee
Item	Vegetation

Levee mile 0.40, vegetation on the waterside of the levee.

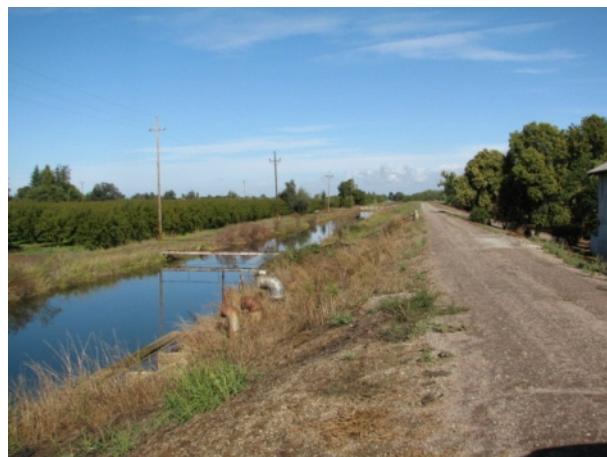
Levee Mile Report Line	10
Start Levee Mile	5.68
End Levee Mile	6.02
Location	Land Side
Category	Earthen Levee
Item	Encroachments

AD at land side toe.

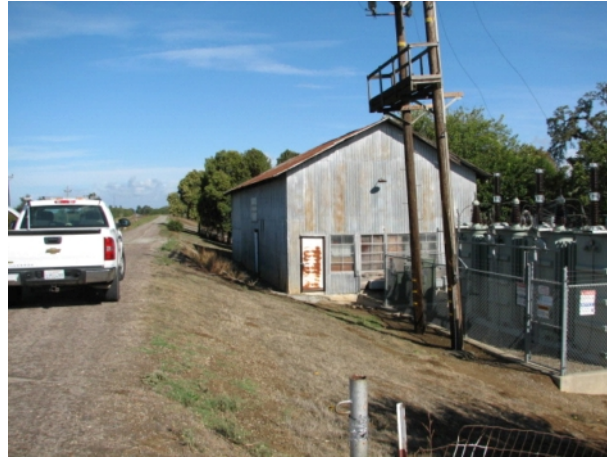
Levee Mile Report Line	11
Start Levee Mile	5.68
End Levee Mile	5.68
Location	Water Side
Category	Earthen Levee
Item	Encroachments
Building at the water side toe.	
cathom_s_20110228_002.jpg
